**Flood Control Project Maintenance
Levee Inspections**

Fall 2010 Levee Maintenance Deficiency Summary Report

San Joaquin River Basin

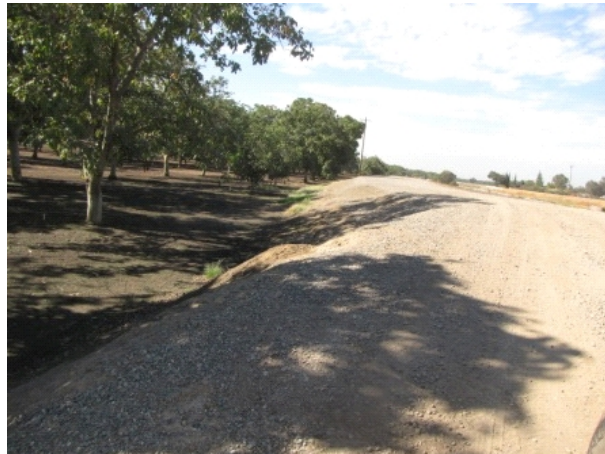
Levee Mile Report Line	64
Start Levee Mile	11.56
End Levee Mile	11.56
Location	Land Side
Category	Earthen Levee
Item	Animal Control
View of the rodent activity on the landward slope looking downstream.7	
dpesaven_f_20101014_488.jpg

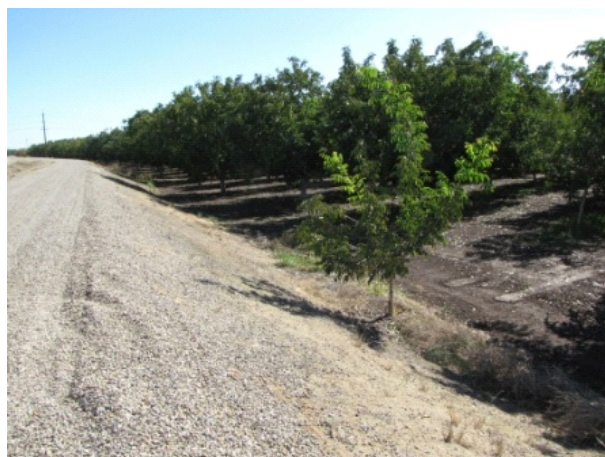
Levee Mile Report Line	70
Start Levee Mile	12.80
End Levee Mile	12.80
Location	Land Side
Category	Earthen Levee
Item	Encroachments
View of a tree planted at the landward toe looking upstream. This tree appears to be planted by the farmer.	
dpesaven_f_20100928_354.jpg

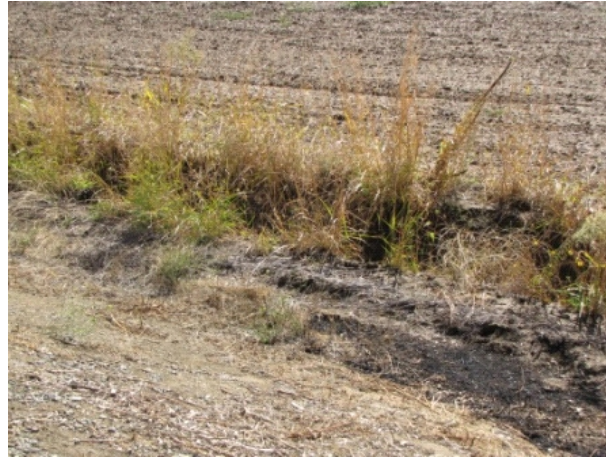
View of an irrigation/drainage ditch along the landward toe.

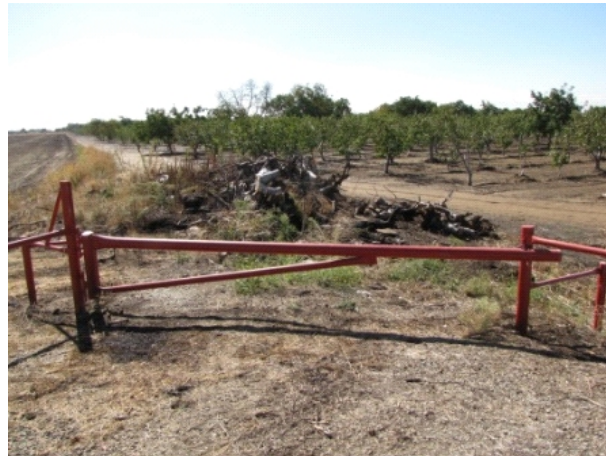
Levee Mile Report Line	72
Start Levee Mile	13.17
End Levee Mile	13.17
Location	Land Side
Category	Earthen Levee
Item	Encroachments

View of a prunings pile along the landward toe of an access ramp. Pile is blocking access through this gate.

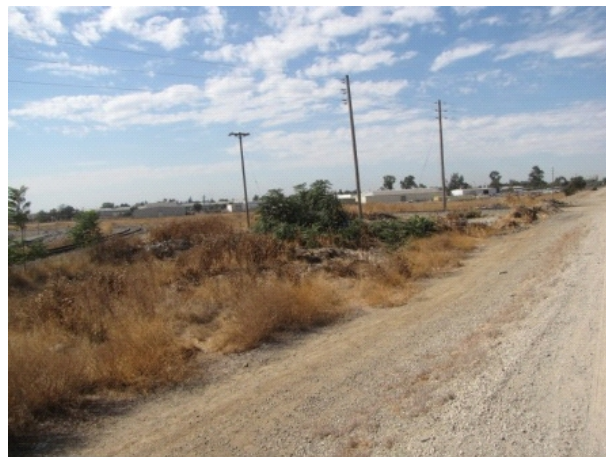
Levee Mile Report Line	77
Start Levee Mile	16.34
End Levee Mile	16.34
Location	Crown
Category	Earthen Levee
Item	Vegetation

View of vegetation within 10 feet of the landward slope looking downstream.

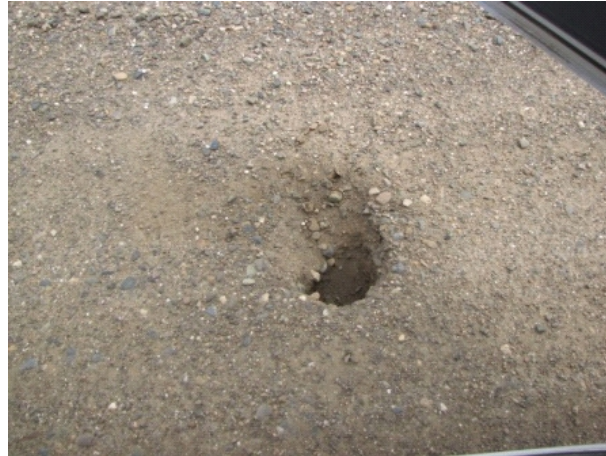
View of a depression in the crown of the levee.

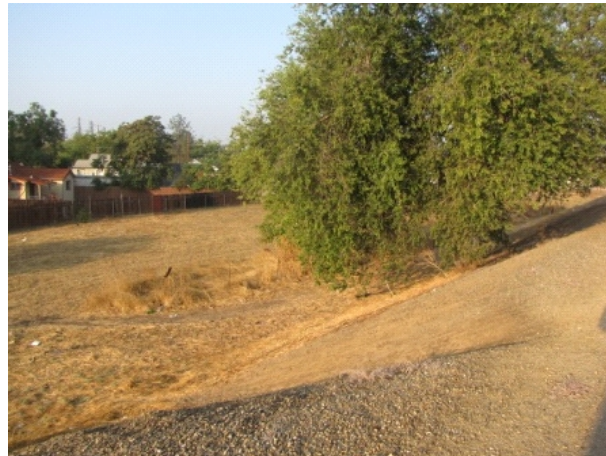
Levee Mile Report Line	80
Start Levee Mile	17.45
End Levee Mile	17.45
Location	Land Side
Category	Earthen Levee
Item	Slope Stability

View of damage to the landward slope caused by vehicular traffic looking downstream.

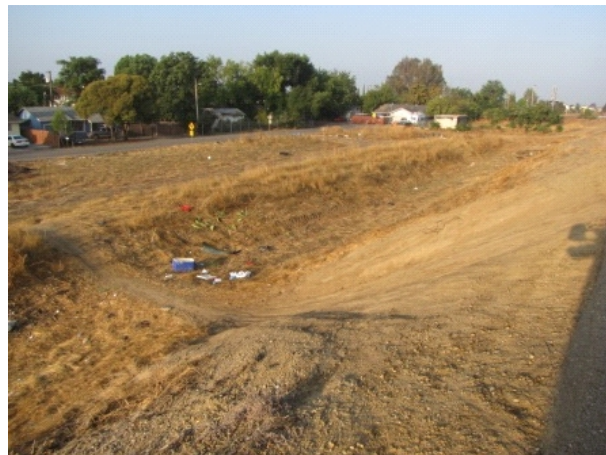
Levee Mile Report Line	83
Start Levee Mile	17.73
End Levee Mile	17.73
Location	Land Side
Category	Earthen Levee
Item	Slope Stability

View of damage to the landward slope caused by vehicular traffic looking downstream.

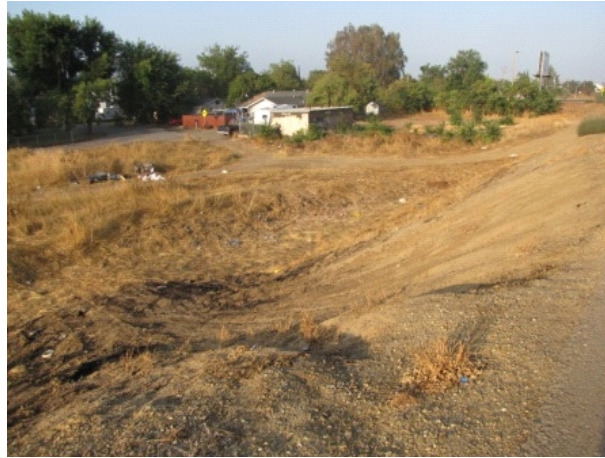
View of damage on the landward slope cause by vehicular traffic looking downstream.

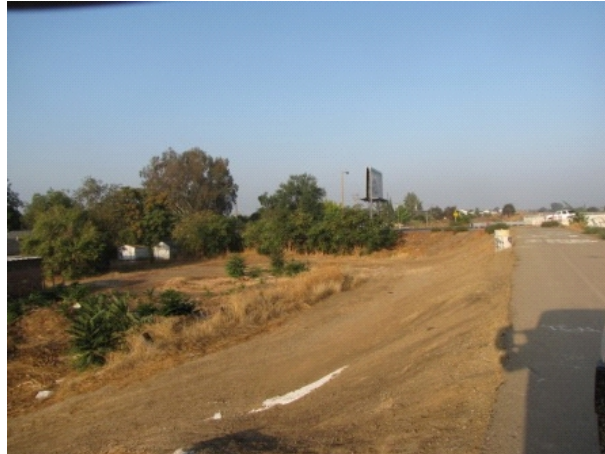
Levee Mile Report Line	85
Start Levee Mile	17.77
End Levee Mile	17.77
Location	Land Side
Category	Earthen Levee
Item	Slope Stability

View of damage to the landward slope caused by vehicular traffic looking downstream.

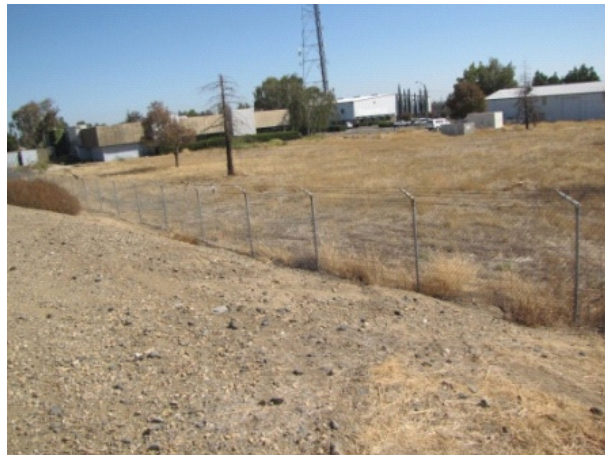
Levee Mile Report Line	90
Start Levee Mile	19.00
End Levee Mile	19.20
Location	Land Side
Category	Earthen Levee
Item	Encroachments

View of a fence along the landward toe looking upstream.

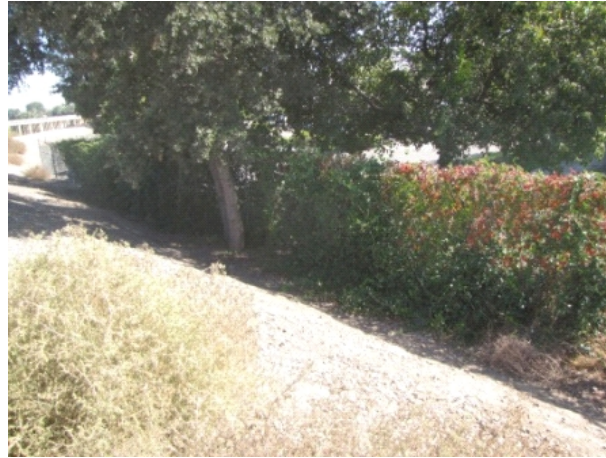
View of landscaping along the landward toe.

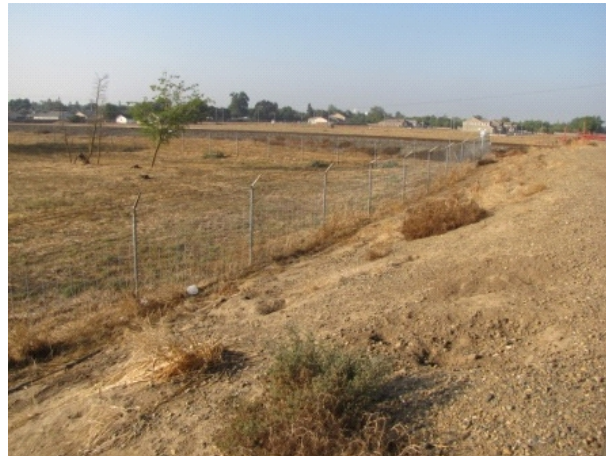
Levee Mile Report Line	93
Start Levee Mile	19.19
End Levee Mile	19.19
Location	Land Side
Category	Earthen Levee
Item	Animal Control

View of rodent activity on the landward slope looking downstream.

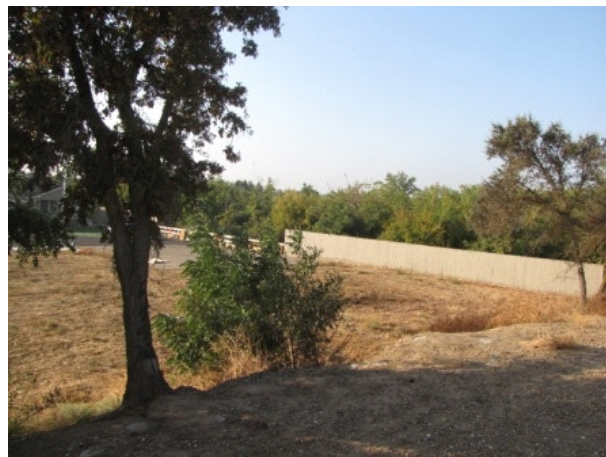
Levee Mile Report Line	97
Start Levee Mile	19.44
End Levee Mile	19.44
Location	Land Side
Category	Earthen Levee
Item	Trim / Thin Trees

View of a tree and vegetation blocking visibility and access along the landward slope and toe looking downstream.

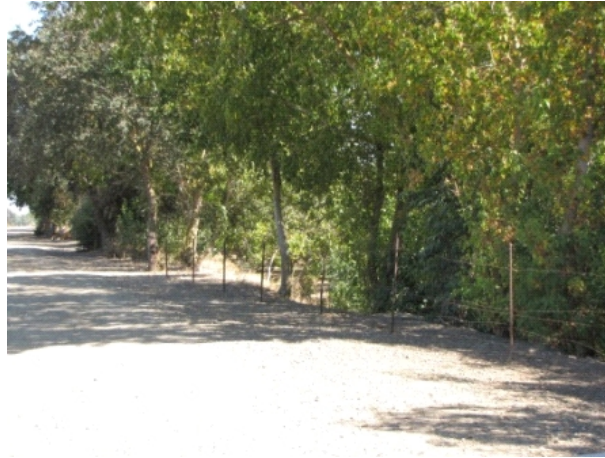
View of a barbed wire fence and landscaping along the landward shoulder and slope looking upstream.

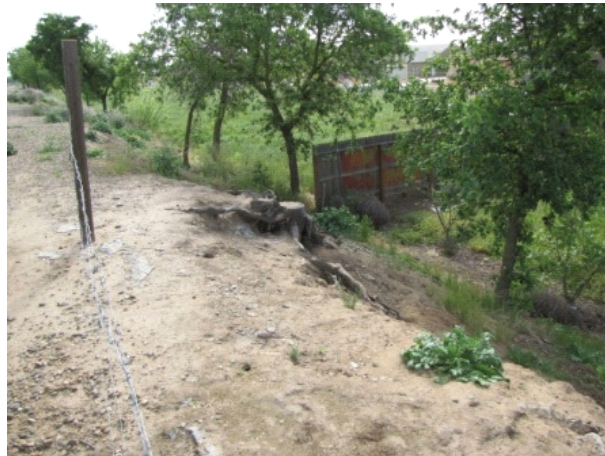
Levee Mile Report Line	103
Start Levee Mile	19.48
End Levee Mile	19.48
Location	Land Side
Category	Earthen Levee
Item	Trim / Thin Trees

View of a stump on the landward slope looking upstream.

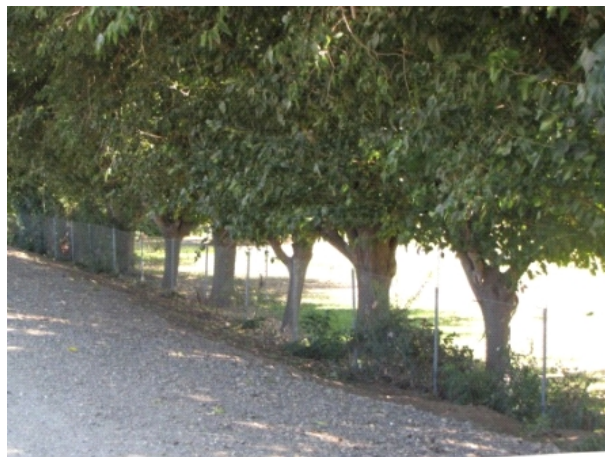
Levee Mile Report Line	105
Start Levee Mile	19.60
End Levee Mile	19.69
Location	Land Side
Category	Earthen Levee
Item	Encroachments

View of a fence along the landward slope looking upstream.

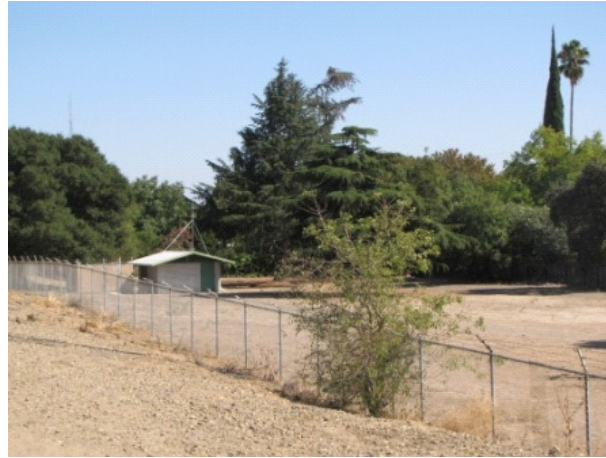
View of a fence along the landward toe looking upstream.

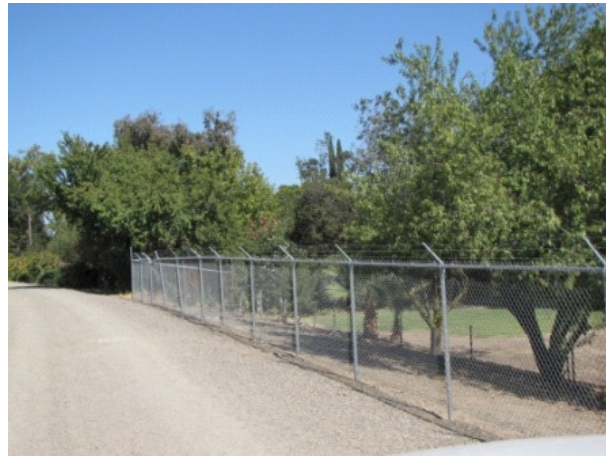
Levee Mile Report Line	126
Start Levee Mile	20.26
End Levee Mile	20.28
Location	Land Side
Category	Earthen Levee
Item	Encroachments

View of a fence along the landward slope looking upstream.

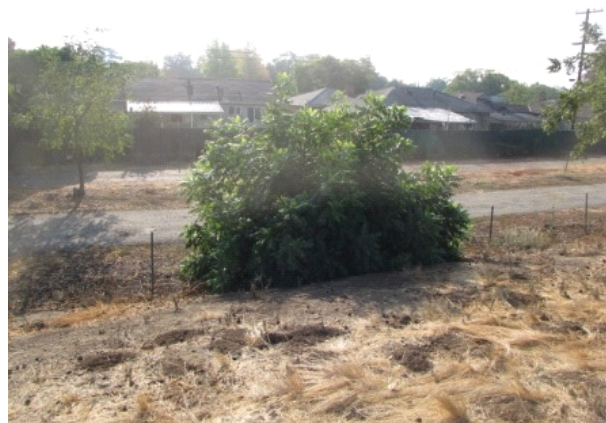
Levee Mile Report Line	127
Start Levee Mile	20.32
End Levee Mile	20.32
Location	Land Side
Category	Earthen Levee
Item	Trim / Thin Trees

View of a tree blocking visibility and access along the landward slope looking landward and downstream.

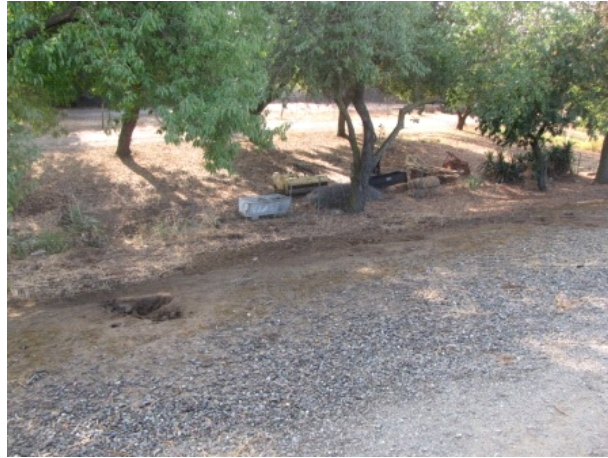
View of rodent activity on the landward slope looking landward and downstream.

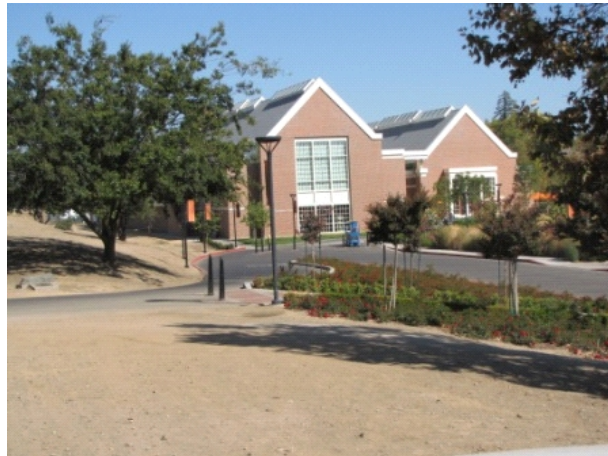
Levee Mile Report Line	130
Start Levee Mile	20.83
End Levee Mile	20.83
Location	Land Side
Category	Earthen Levee
Item	Encroachments

View of landscaping planted and maintained by UOP along the landward slope and toe looking upstream.

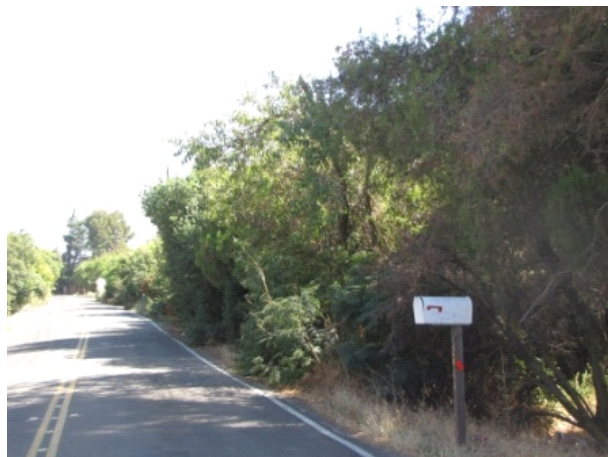
Levee Mile Report Line	153
Start Levee Mile	22.17
End Levee Mile	22.37
Location	Land Side
Category	Earthen Levee
Item	Encroachments

View of landscaping along landward slope looking upstream.

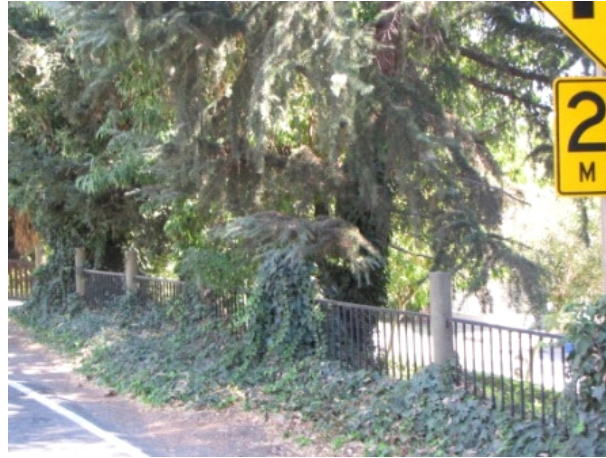
View of a fence and landscaping along the landward shoulder and slope looking upstream.

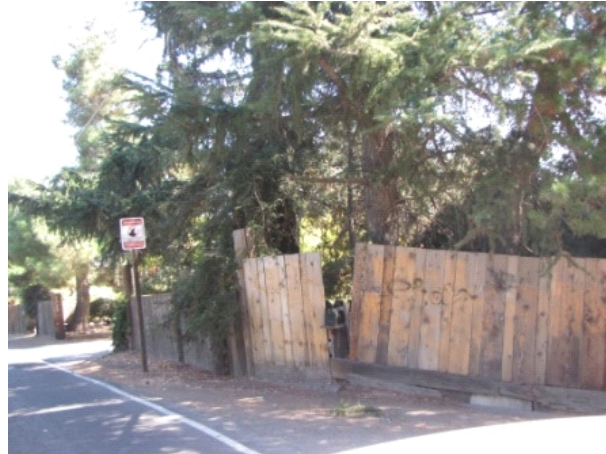
Levee Mile Report Line	155
Start Levee Mile	22.19
End Levee Mile	22.21
Location	Land Side
Category	Earthen Levee
Item	Encroachments

View of a fence along the landward shoulder and slope looking upstream.

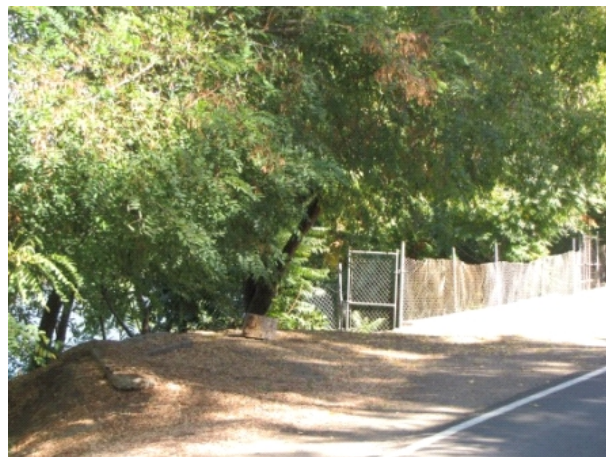
Levee Mile Report Line	156
Start Levee Mile	22.19
End Levee Mile	22.21
Location	Water Side
Category	Earthen Levee
Item	Encroachments

View of a fence along the waterward shoulder and slope looking upstream.

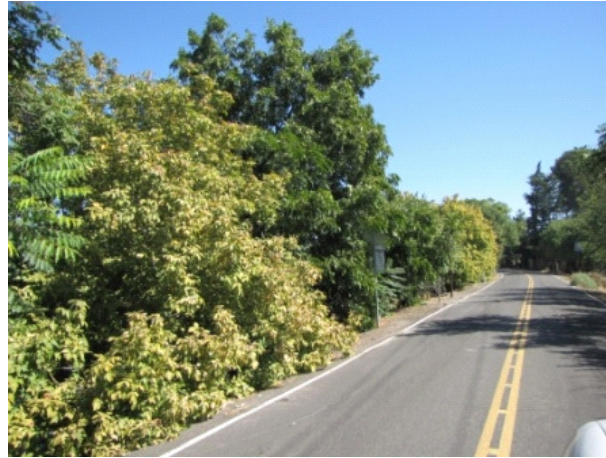
View of trees along the waterward slope obstructing visibility and access looking upstream.

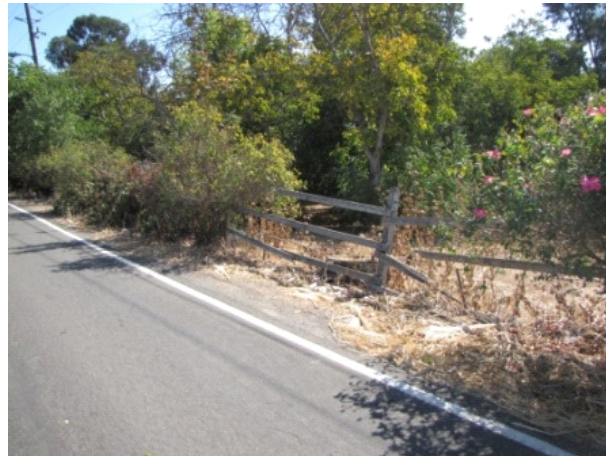
Levee Mile Report Line	158
Start Levee Mile	22.26
End Levee Mile	22.30
Location	Land Side
Category	Earthen Levee
Item	Encroachments

View of a fence along the landward shoulder looking upstream.

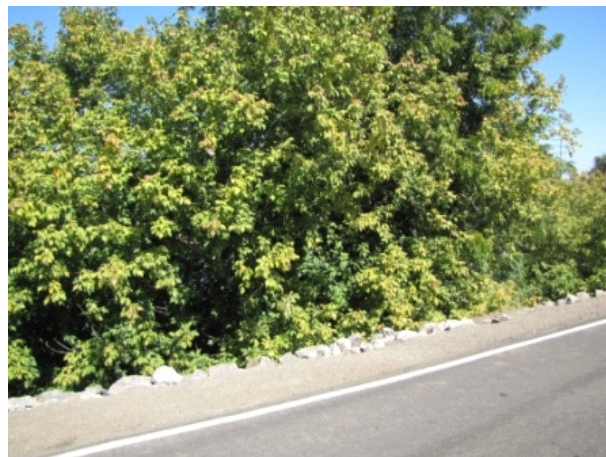
Levee Mile Report Line	159
Start Levee Mile	22.31
End Levee Mile	22.31
Location	Water Side
Category	Earthen Levee
Item	Trim / Thin Trees

View of trees on the waterward slope obstructing visibility and access looking upstream.

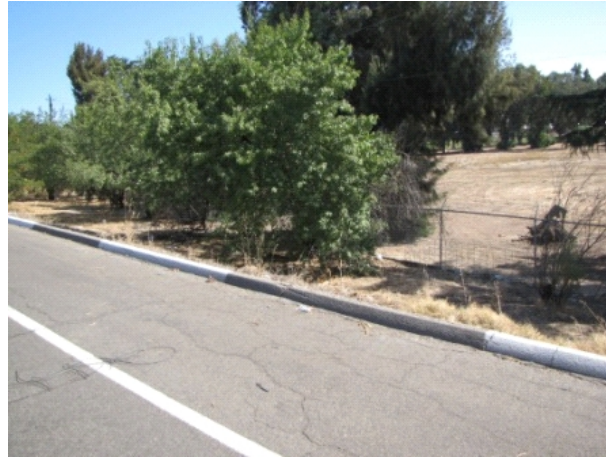
View of fence and landscaping along landward slope looking upstream.

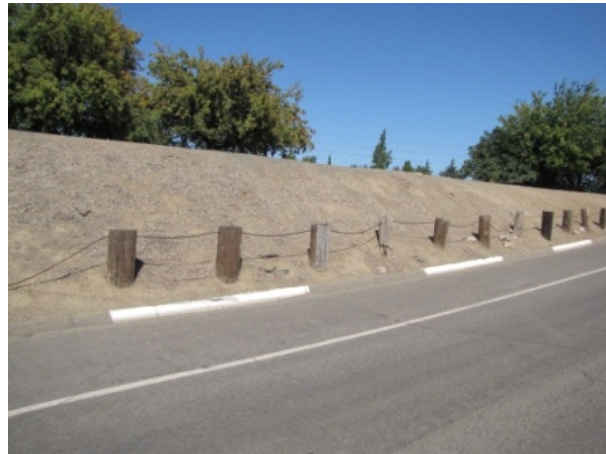
Levee Mile Report Line	161
Start Levee Mile	22.43
End Levee Mile	22.46
Location	Land Side
Category	Earthen Levee
Item	Encroachments

View of a post and cable fence along the landward slope looking upstream.

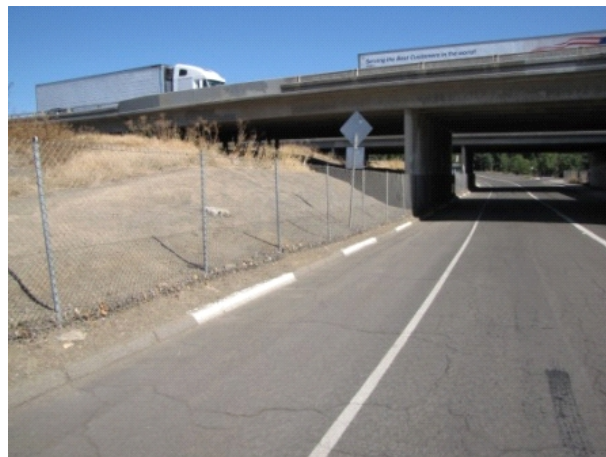
dpesaven_f_20100928_334.jpg

View of fence along landward toe looking upstream.

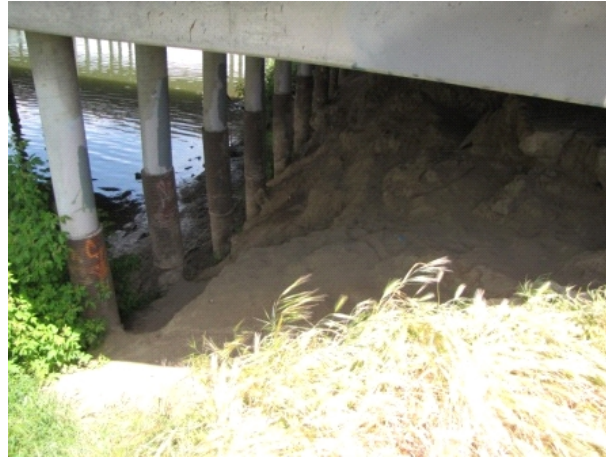
dpesaven_f_20100928_309.jpg

163	22.52	22.52	Earthen Levee	Slope Stability	WS	U	Repair slope instability. Inspector Comments: Waterward bank damaged under I-5 and shows significant erosion.	37.978697 ° -121.341581 °	37.978697 ° -121.341581 °	48 Y
164	22.52	22.57	Earthen Levee	Encroachments	LS	PO	Fences Inspector Comments: Post and cable fence	37.978464 ° -121.341620 °	37.978208 ° -121.342190 °	114 Y
165	22.57	22.57	Earthen Levee	Trim / Thin Trees	WS	M	Trim trees to at least five feet above ground level.	37.978287 ° -121.342331 °	37.978287 ° -121.342331 °	181
166	22.58	22.87	Earthen Levee	Encroachments	LS	PO	Landscaping	37.978078 ° -121.342523 °	37.975086 ° -121.346027 °	111
167	22.58	22.87	Earthen Levee	Encroachments	LS	PO	Fences	37.978081 ° -121.342519 °	37.975086 ° -121.346027 °	110 Y
168	22.75	22.75	Earthen Levee	Trim / Thin Trees	WS	M	Trim trees to at least five feet above ground level.	37.976394 ° -121.344632 °	37.976394 ° -121.344632 °	113 Y

View of slope instability on the waterward slope under I-5 looking upstream.

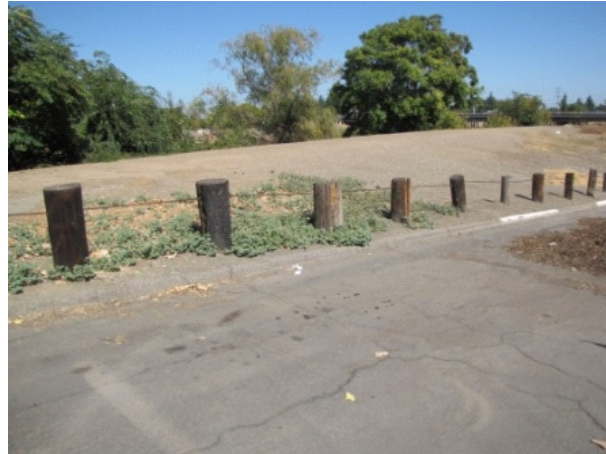
Levee Mile Report Line	164
Start Levee Mile	22.52
End Levee Mile	22.57
Location	Land Side
Category	Earthen Levee
Item	Encroachments

View of post and cable fence along the landward levee slope looking upstream.

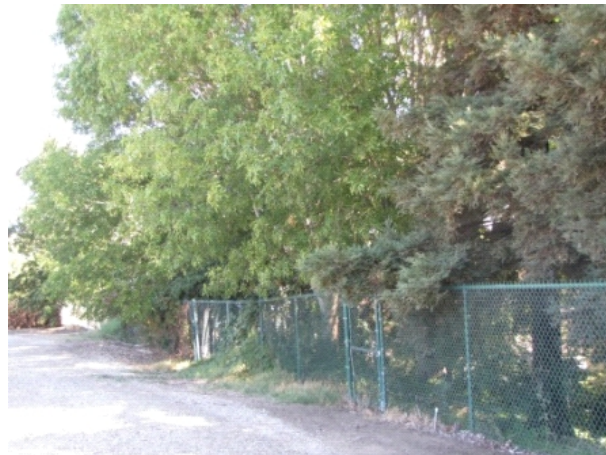
Levee Mile Report Line	167
Start Levee Mile	22.58
End Levee Mile	22.87
Location	Land Side
Category	Earthen Levee
Item	Encroachments

View of fence and landscaping along the landward shoulder and slope looking upstream.

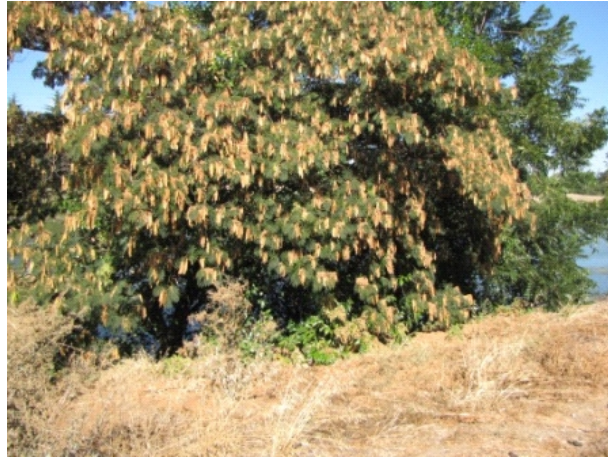
dpesaven_f_20100928_332.jpg

View of a tree blocking visibility and access along the waterward slope.

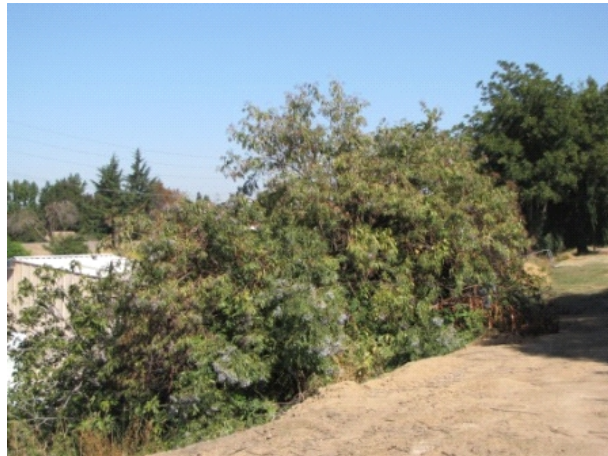
Levee Mile Report Line	169
Start Levee Mile	22.86
End Levee Mile	22.86
Location	Land Side
Category	Earthen Levee
Item	Vegetation

View of elderberry bushes along the waterward slope looking upstream.

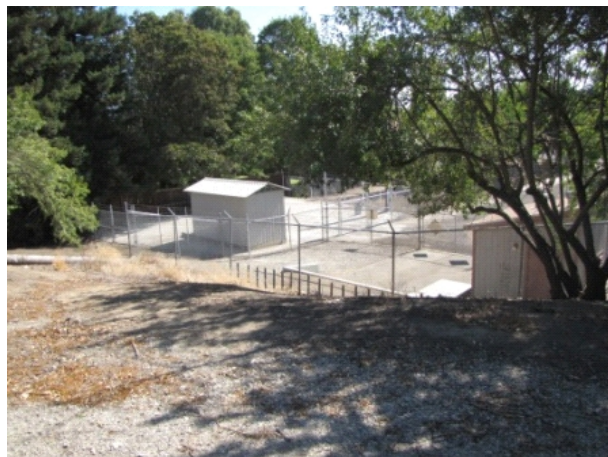
Levee Mile Report Line	170
Start Levee Mile	22.87
End Levee Mile	22.89
Location	Land Side
Category	Earthen Levee
Item	Encroachments

View of fence along the landward slope.

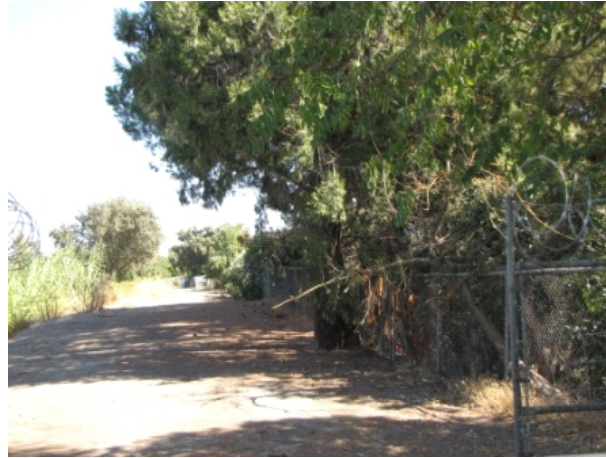
dpesaven_f_20100928_328.jpg

View of fence and landscaping along the landward shoulder looking upstream.

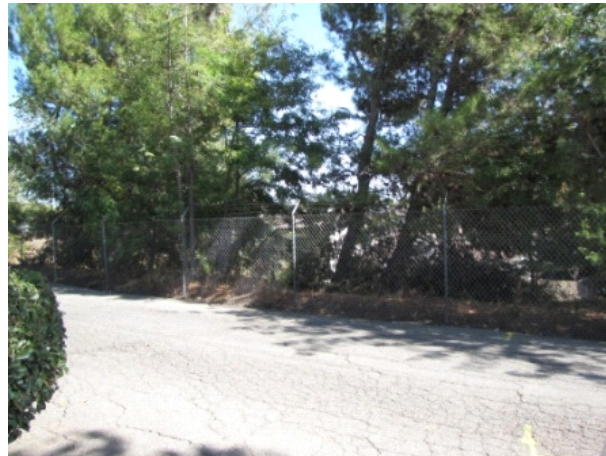
Levee Mile Report Line	174
Start Levee Mile	23.08
End Levee Mile	23.22
Location	Land Side
Category	Earthen Levee
Item	Encroachments

View of fence along the landward shoulder looking upstream.

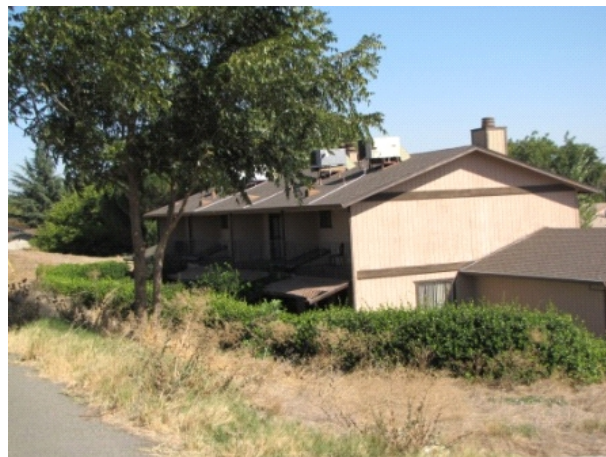
Levee Mile Report Line	177
Start Levee Mile	23.24
End Levee Mile	23.27
Location	Land Side
Category	Earthen Levee
Item	Encroachments

View of landscaping along the landward slope looking upstream.

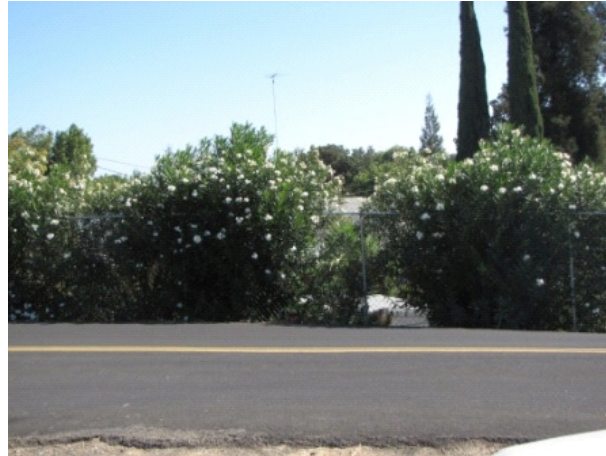
dpesaven_f_20100928_324.jpg

View of fence and landscaping along the landward slope.

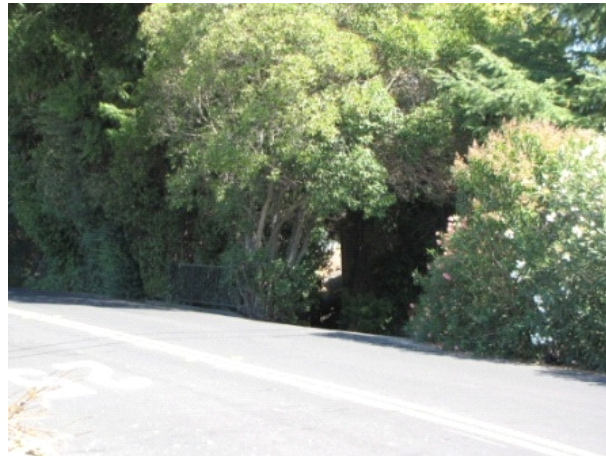
Levee Mile Report Line	179
Start Levee Mile	23.30
End Levee Mile	23.34
Location	Land Side
Category	Earthen Levee
Item	Encroachments

View of landscaping along the landward levee slope looking upstream.

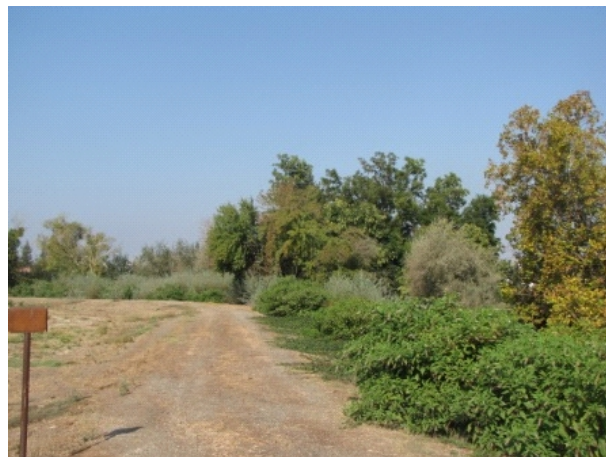
Levee Mile Report Line	180
Start Levee Mile	23.70
End Levee Mile	23.70
Location	Water Side
Category	Earthen Levee
Item	Encroachments

View of vegetation along the waterward slope looking downstream.

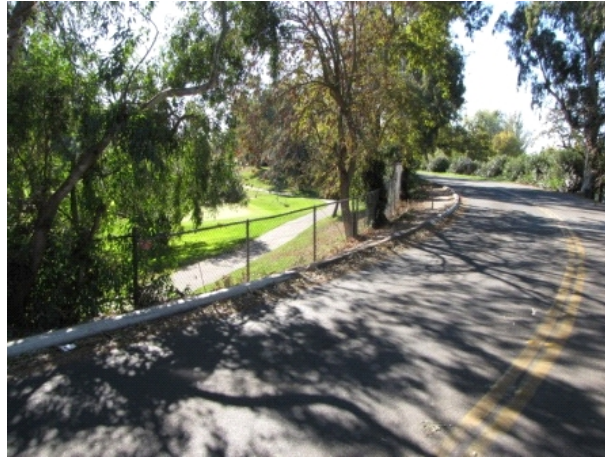
dpesaven_f_20100928_369.jpg

View of the fence along the landward slope looking downstream.

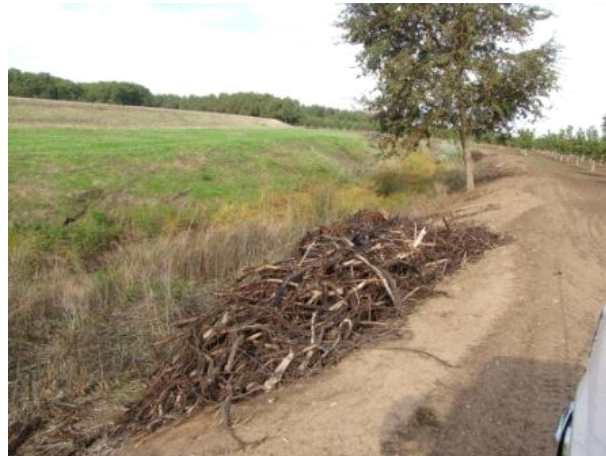
Levee Mile Report Line	2
Start Levee Mile	0.13
End Levee Mile	0.13
Location	Water Side
Category	Earthen Levee
Item	Encroachments

View of a prunings pile along the waterward bank looking downstream.

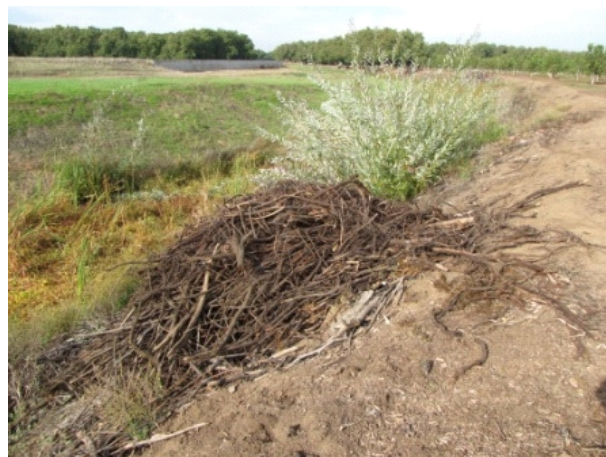
Levee Mile Report Line	3
Start Levee Mile	0.17
End Levee Mile	0.17
Location	Water Side
Category	Earthen Levee
Item	Encroachments

View of a prunings pile along the waterward bank looking downstream.

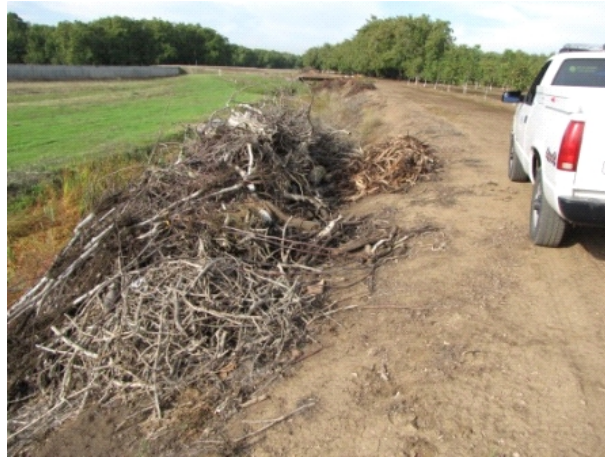
dpesaven_f_20100928_373.jpg

View of a prunings pile along the waterward bank looking downstream.

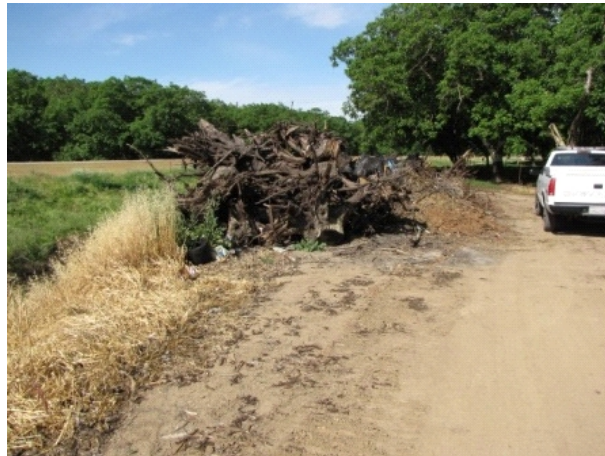
Levee Mile Report Line	7
Start Levee Mile	0.37
End Levee Mile	0.37
Location	Water Side
Category	Earthen Levee
Item	Encroachments

Debris pile located on waterside of levee at LM 0.50.
